COMPOSITE ANCHORING, GROUTING AND STABILIZATION OF THE BRISTOL MARITIME ARMORY

BY JOHN M. WATHNE

Bristol Maritime Armory Stabilization Bristol, Rhode Island

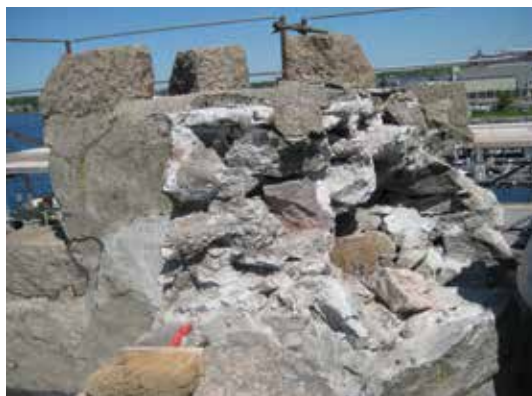
The first phase of repairs focused on the severely-cracked northeast turret and the cracked and bulging east elevation (Fig 2 and 3). Initially, the repairs were intended to consist of through-pinning the elevation and gravity-filling and packing the back-up construction with mortar and chinking stones by opening small windows at removed stone. However, the conditions encountered during construction were so severe it was determined that it would be necessary to do a comprehensive reconstruction of the middle portion of the façade and a total reconstruction of the turret.

Fig. 2: Internal turret condition

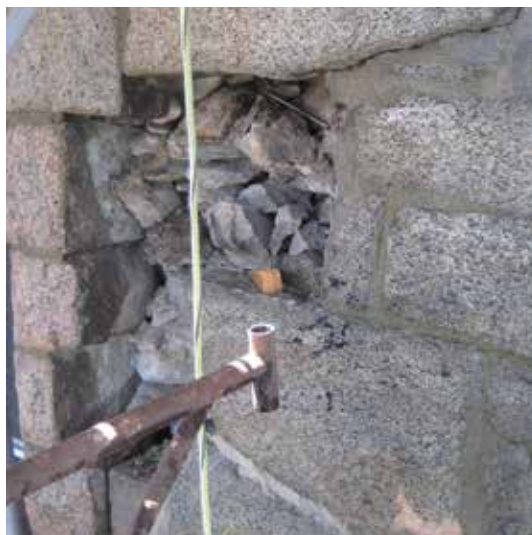
- A dangerously large bulge exists in the north half of the east wall at about mid height. By creating a hole in the window surround within the bulged area, it was apparent that the bulge was actually a separation between the exterior stone leaf and the random stone back-up construction.

Fig. 3: Internal wall condition

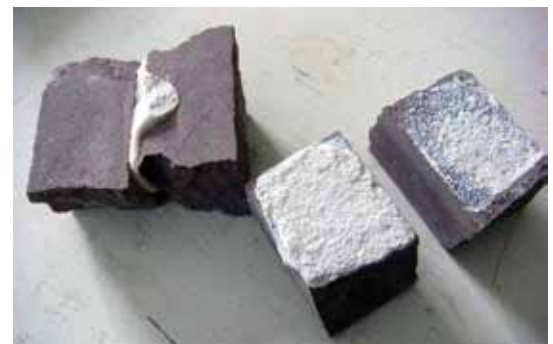
High Adhesive Strength: It is important that the grout be adhesive enough to bond surfaces together with an adhesive strength that equals or exceeds the cohesive strength of the grout (Fig. 6). This is so that any shrinkage that did occur would result in jagged microcracks within the grout rather than in debonding from the substrate surfaces.

Fig. 6: Bond test specimens

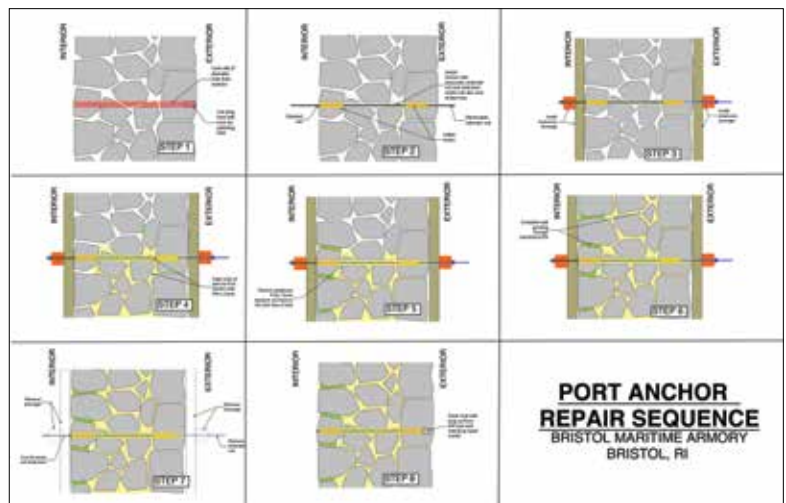
The first step was to perform an updated survey of the structure to lay out the anchor locations. Anchors were positioned where they could be of the greatest value, such as along cracks, at the centers of bulges, and at protruding large stones (Fig. 8). Holes were core-drilled through the wall and the outer leaf, and back-up thicknesses were determined. Interestingly, between 10 and 20 per-

Fig. 8: Port anchor repair sequence

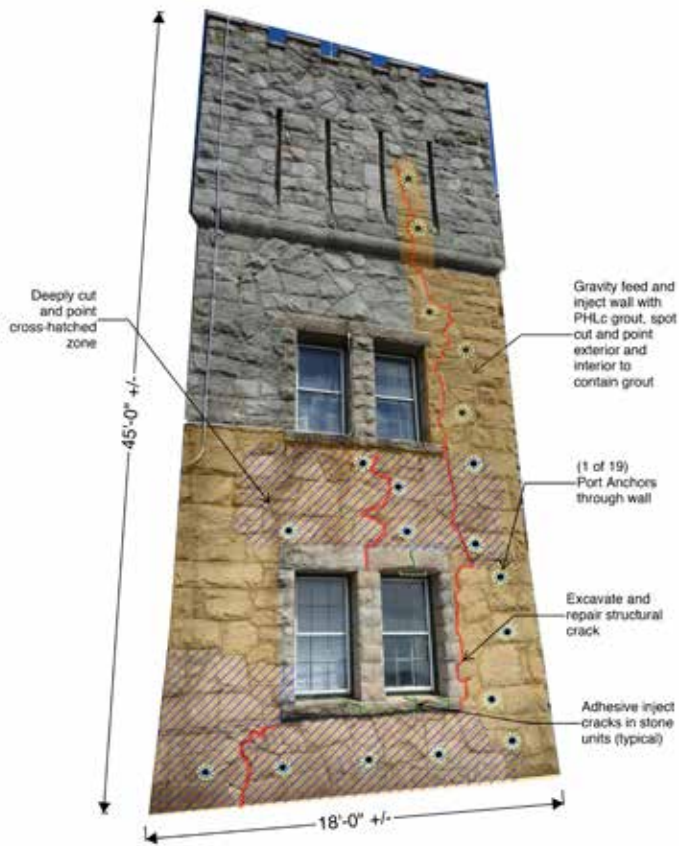
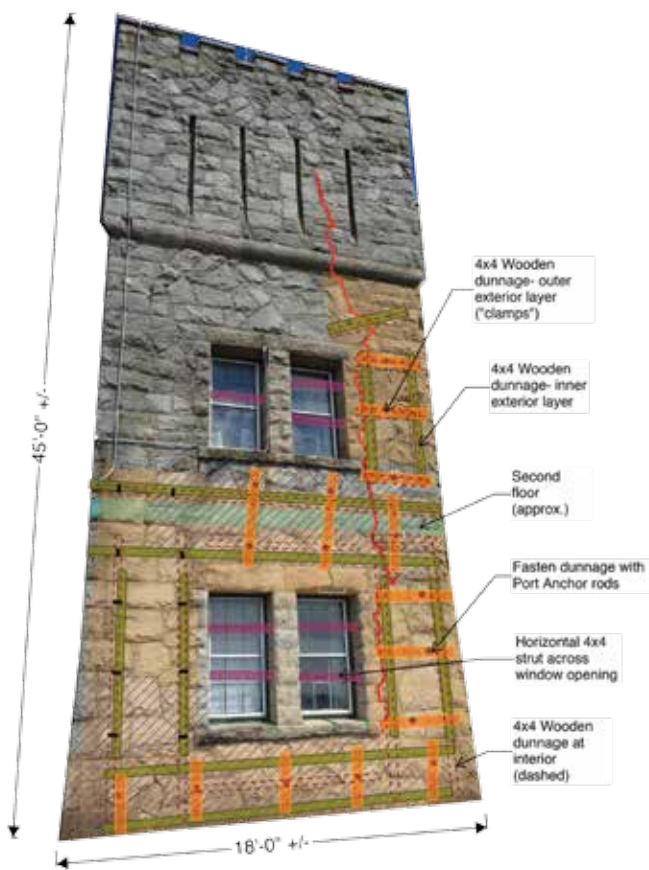
Fig. 9: Repairs and dunnage on west elevation/north half

Next, the mortar joints at the exterior were cut and repointed along with accessible, damaged mortar joints at the interior. Because of the presence of floor framing, wall returns, and in a few places interior finishes, a combination of single-ended and double-ended anchors would be used. Additionally, because of the extremely poor condition of the masonry, wooden dunnage was needed at both the exterior and interior.

Anchors were installed by inflating the fabric socks with a high strength grout, and the dunnage system was fastened to the exterior by rods that were threaded into recessed inserts in the ends of the anchors. After the anchor installation and dunnage system were complete (Fig. 9), grouting of the wall began, working from the bottom up using the port anchors as well as supplemental holes drilled into

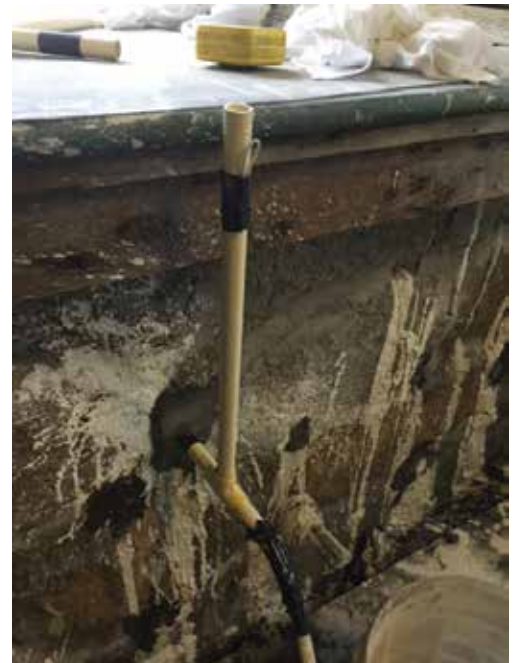
Fig. 10: In-line injection piezometer

the interior. Grout lifts were limited to 3 ft (1 m) per day, and a system of pressure-limiting in-line piezometers (Fig. 10) was devised to avoid internal grouting pressure spikes when refusal was reached.

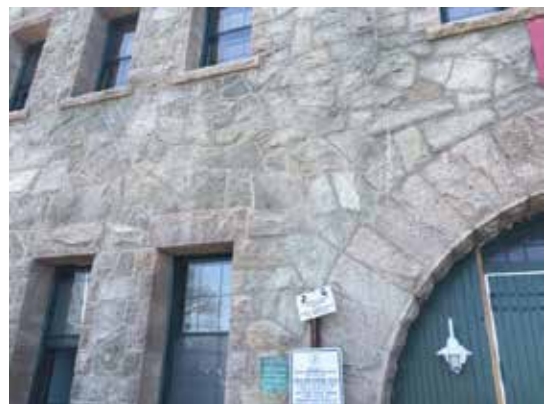
Fig. 11: Completed work before final wash-down

After the first round of grout injection was complete, several rounds of holes were drilled into the wall to confirm that it had been solidly filled. Where voids were encountered, the holes were then used for re-injection. After the walls were solidly filled, the dunnage and extension rods were removed, and the anchor holes were filled by bonding thin “biscuits” that were cut from the outer ends of the corresponding cores. A section of completed work is shown on Fig. 11.
