COMPOSITE ANCHORING, GROUTING AND STABILIZATION OF THE BRISTOL MARITIME ARMORY

BY JOHN M. WATHNE

Bristol Maritime Armory Stabilization Bristol, Rhode Island

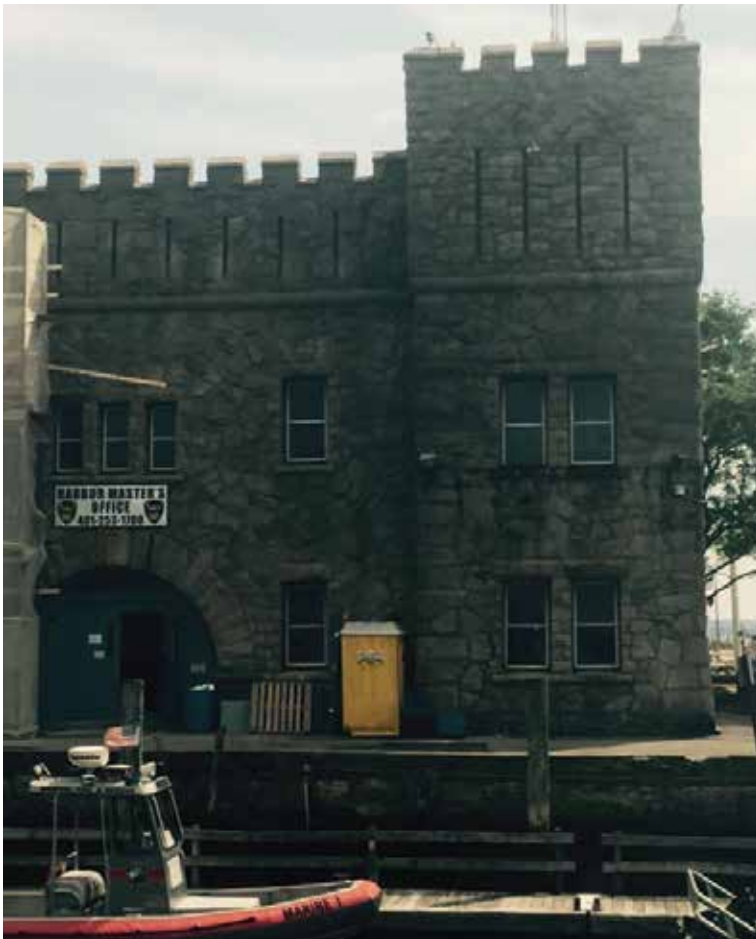
Fig. 1: The Bristol Maritime Armory

The Bristol Maritime Armory, on a wharf in Bristol, Rhode Island, is an imposing two and one-half story turreted granite edifice that appears to stand guard on the Bristol Harbor (Fig. 1). Behind its imposing façade; however, it is a poorly-constructed stack of unbonded stonework. Nineteenth century newspaper articles state that the Armory walls were cracking and bulging even in the first few years following its construction.
